UNITED STATES ENVIRONMENTAL PROTECTION AGENCY
REGION 2
290 BROADWAY
NEW YORK, NY 10007-1866

Re: Phillips 66 Co., Bayway Refinery, Linden NJ
EPA/NJDEP NJPDES Permit Compliance Evaluation Inspection June 12, 13, and 20, 2019
NJPDES Permit No. NJ0001511 (NJPID No. 46318), NJ0026671 (NJPID No. 46322)

Enclosure – Inspection Report from June 2019 CEI

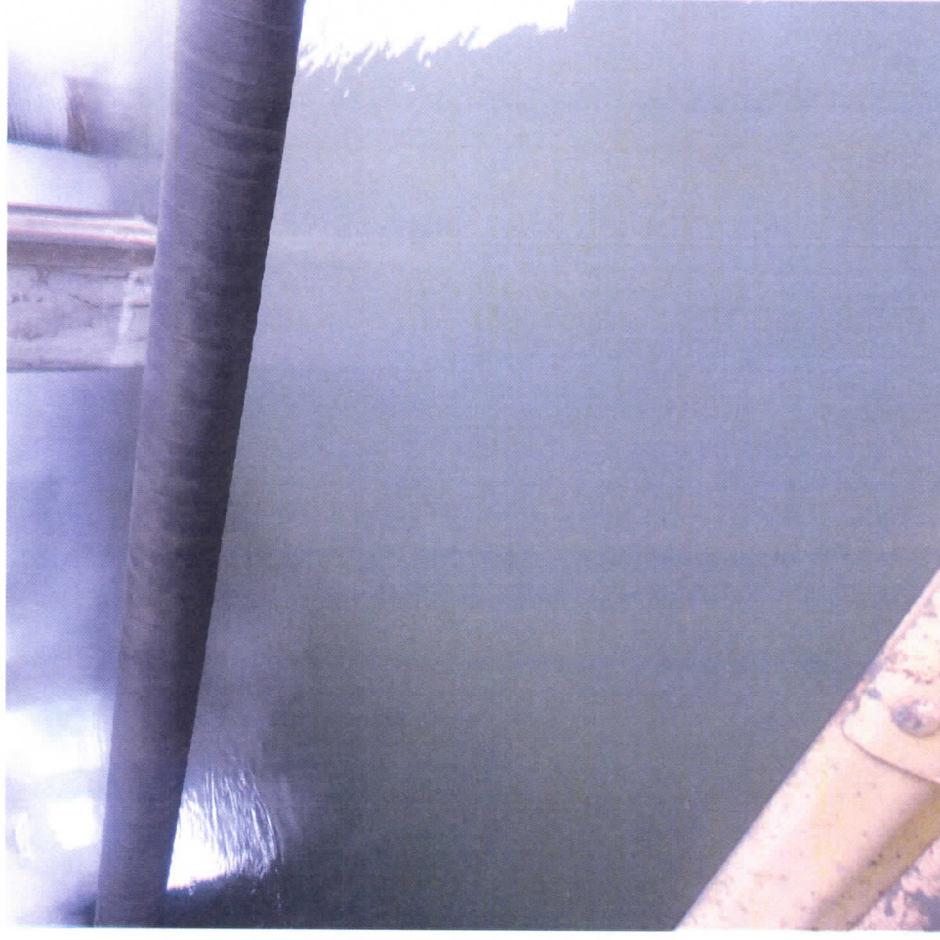
DSCN6895 – outfall 005 – no sheen or foam

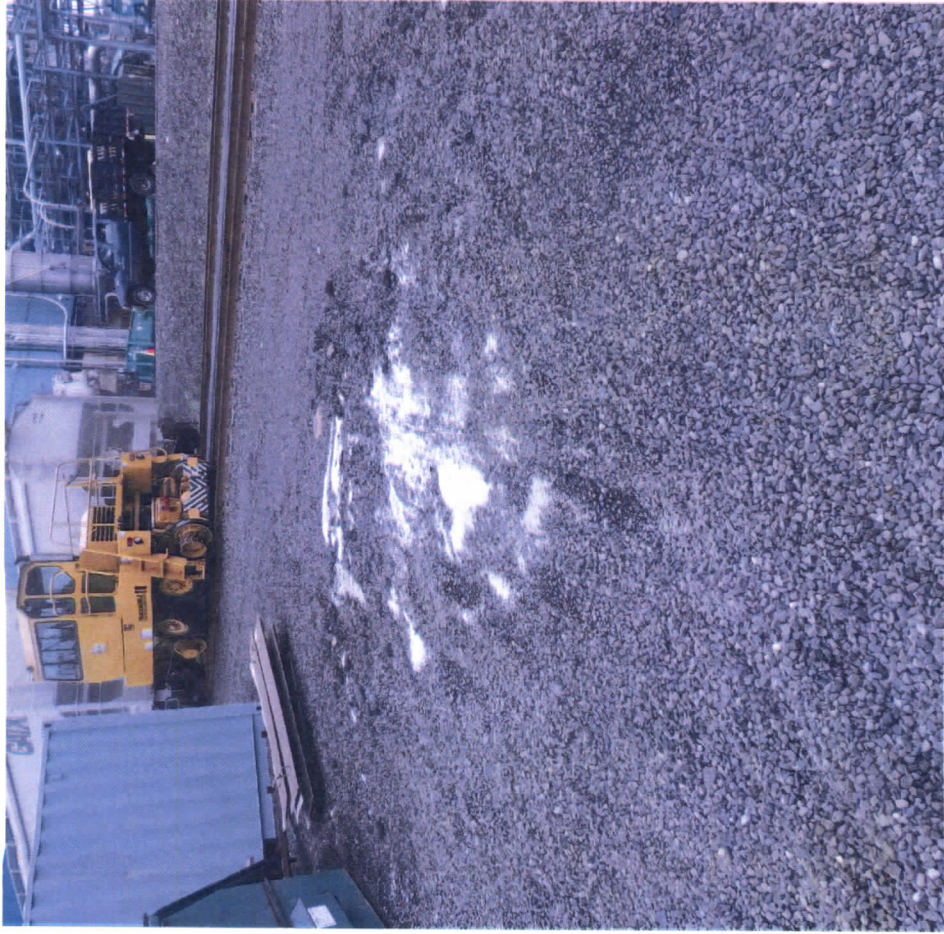
DSCN6902 - Polypropylene pellens on ground near
polypropylene area.

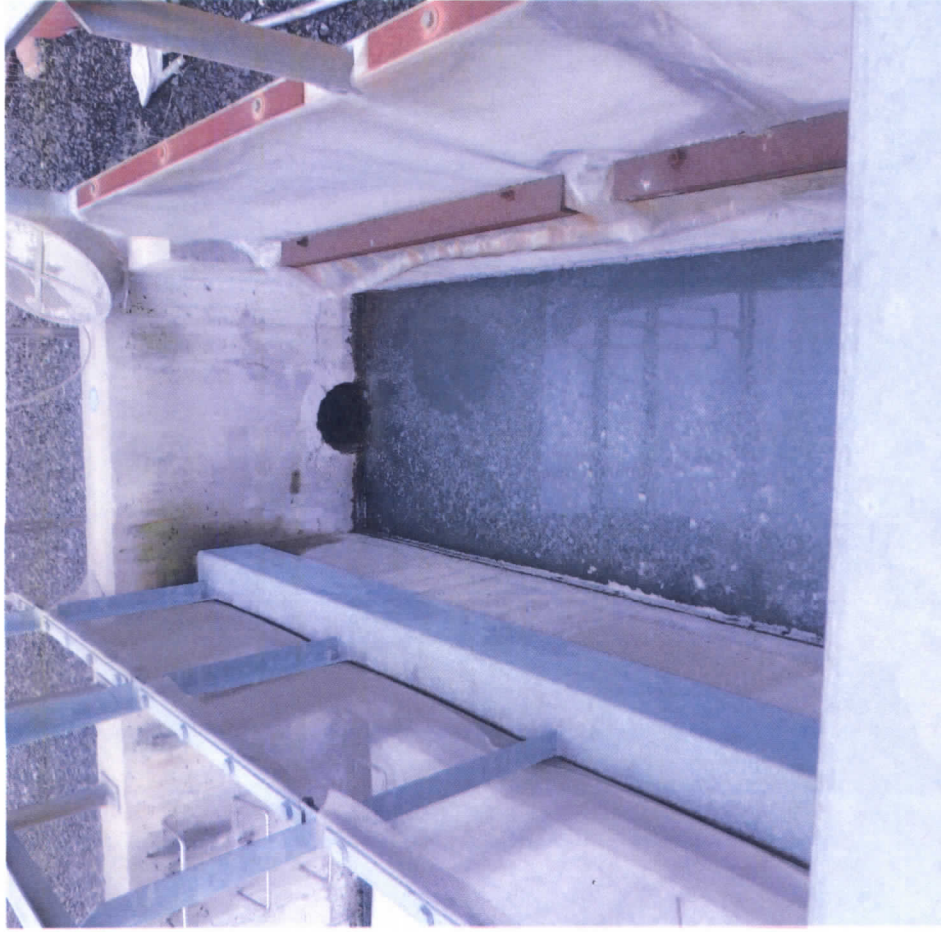
DSCN6904 – effluent end of polypropylene area separator
discharging floating pellets to Outfall 005

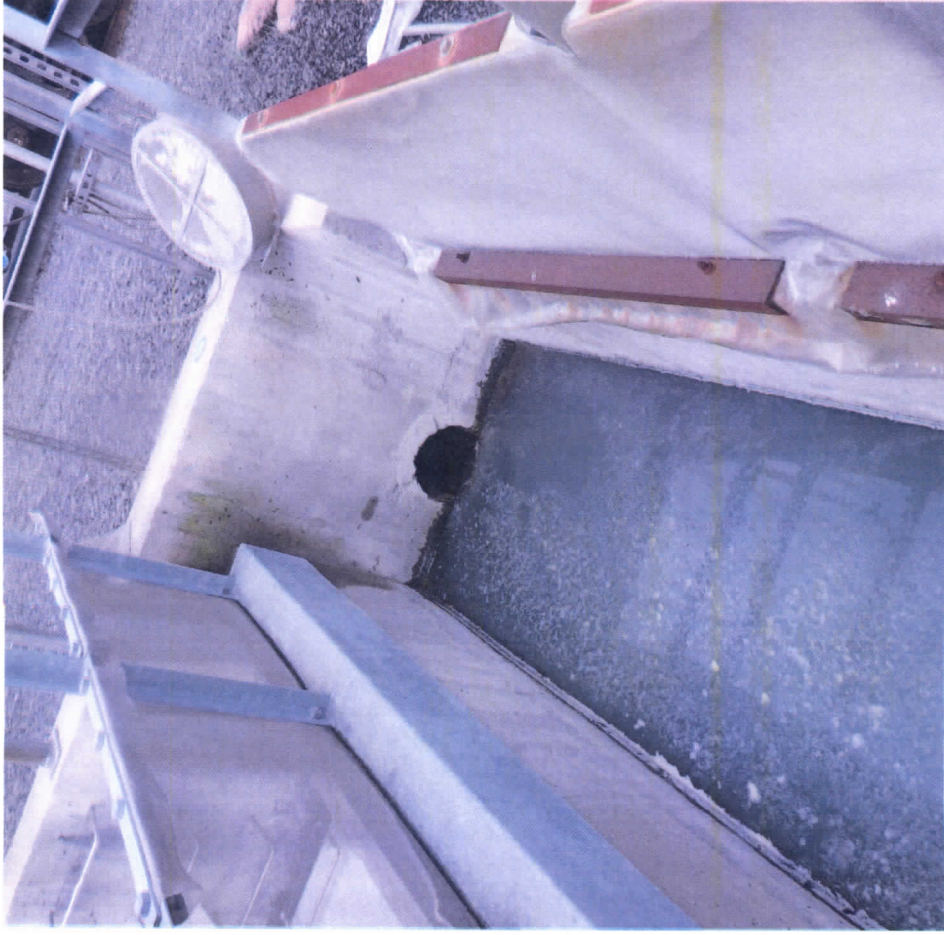
DSCN6906 - effluent end of polypropylene area separator discharging floating pellets to Outfall 005 – Outlet pipe cover not on outlet –but on wall.

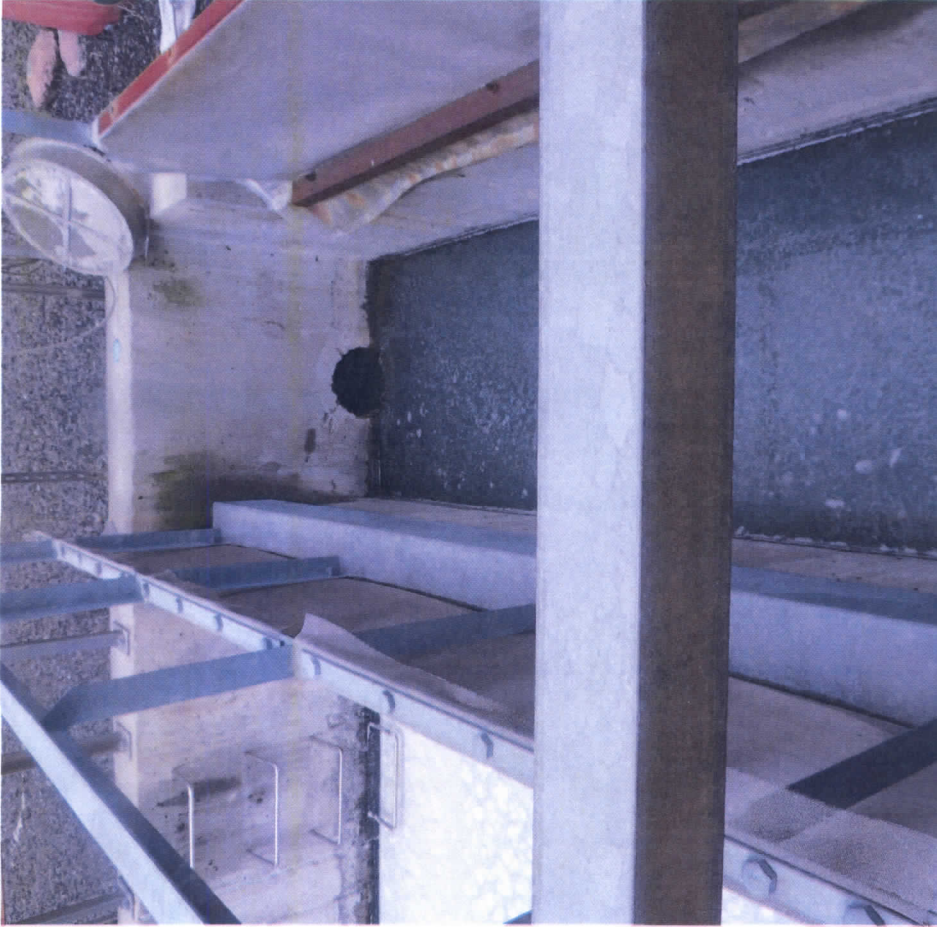
DSCN6908 - effluent end of polypropylene area separator
discharging floating pellets to Outfall 005 - Outlet pipe cover
not on outlet –but on wall.

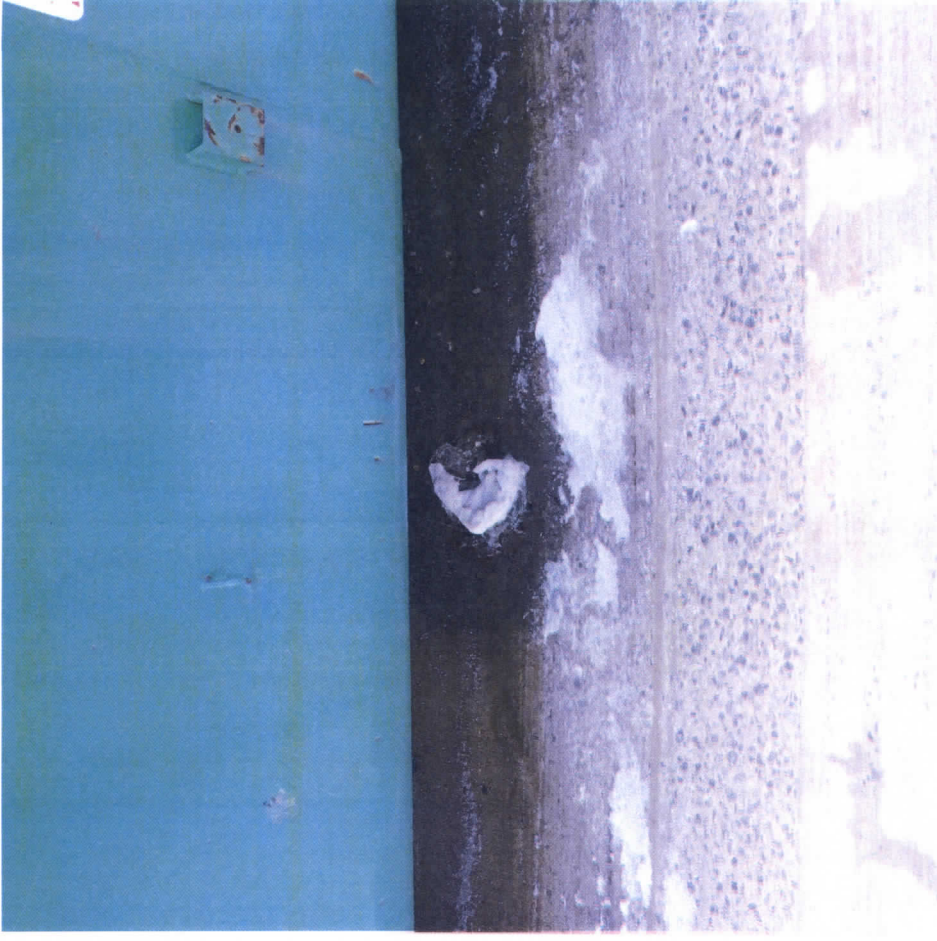
DSCN6909 – Polypropylene pellets on ground in
polypropylene area

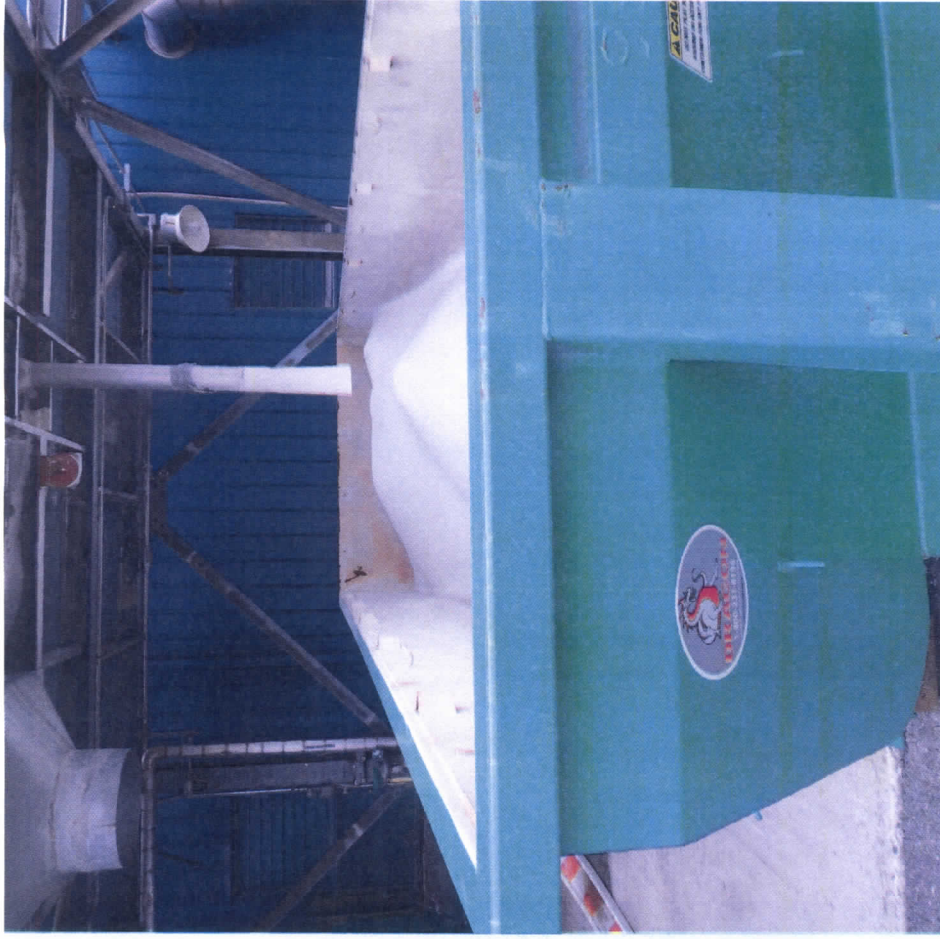
DSCN6914 – open dumpster with Polypropylene baghouse waste that could be blown out of dumpster – not covered

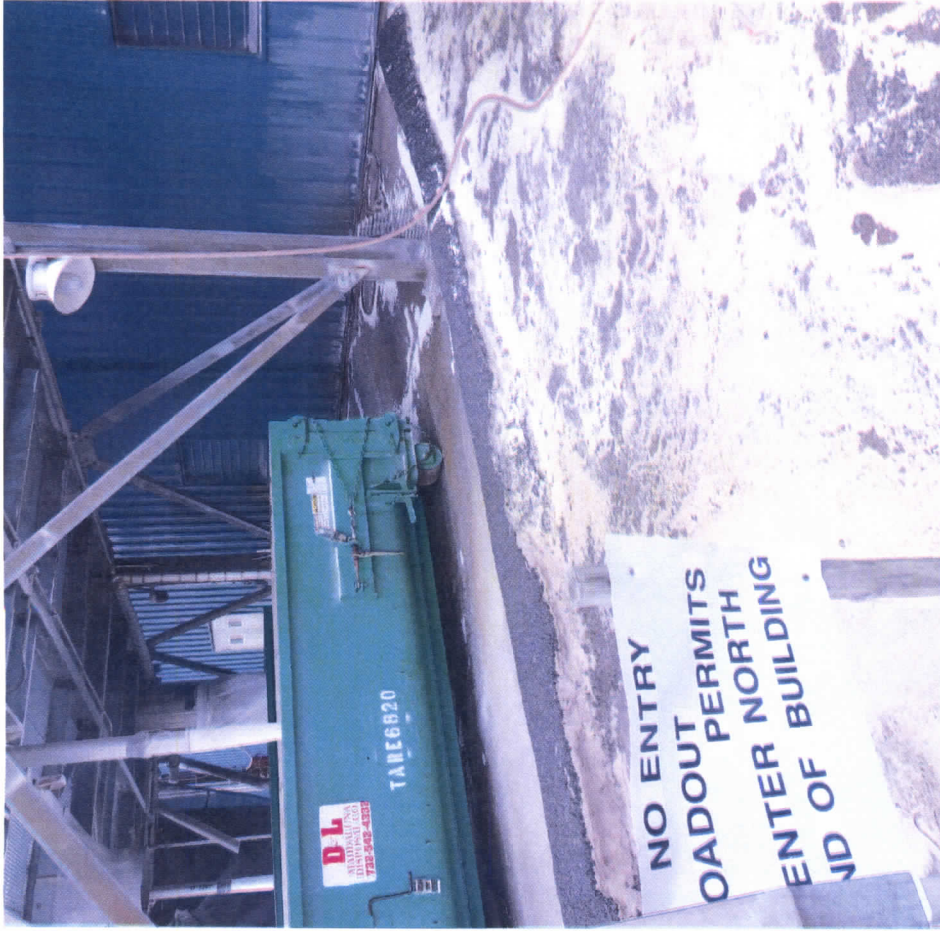
DSCN6917 – polypropylene pellets/material on ground dumpsters

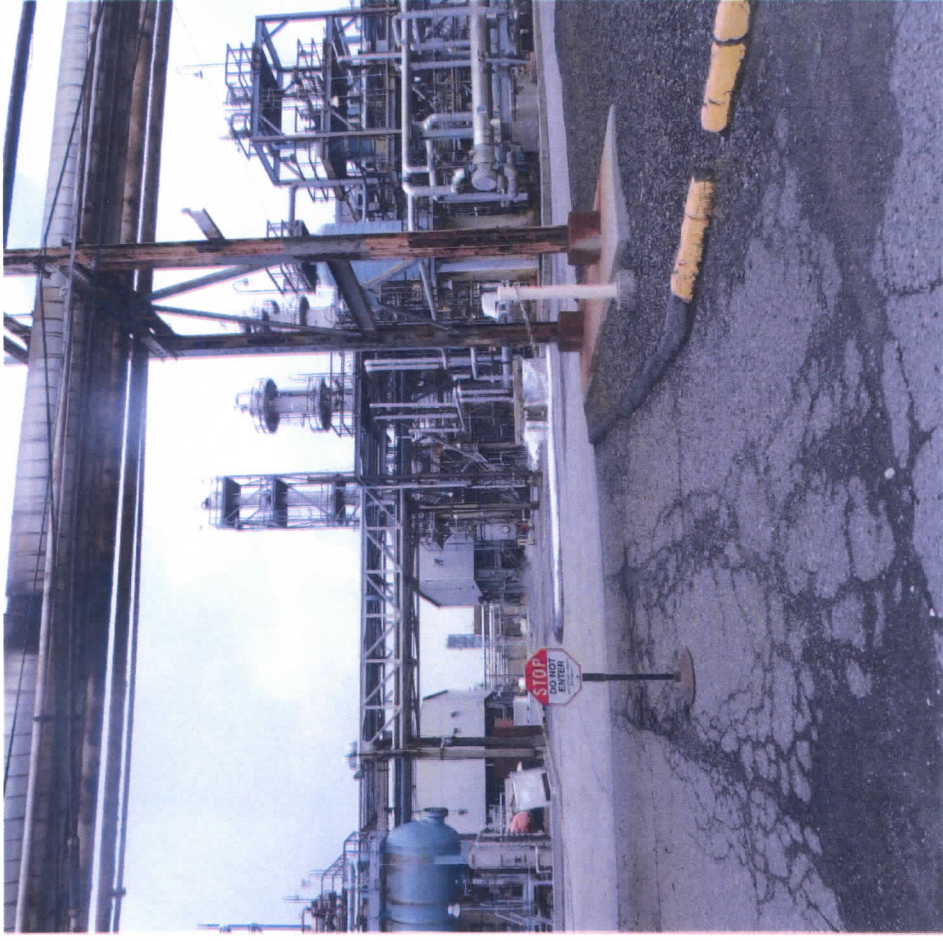
DSCN6927 – Overflow of ISO Unit onto ground – said that
it flows to the process sewer

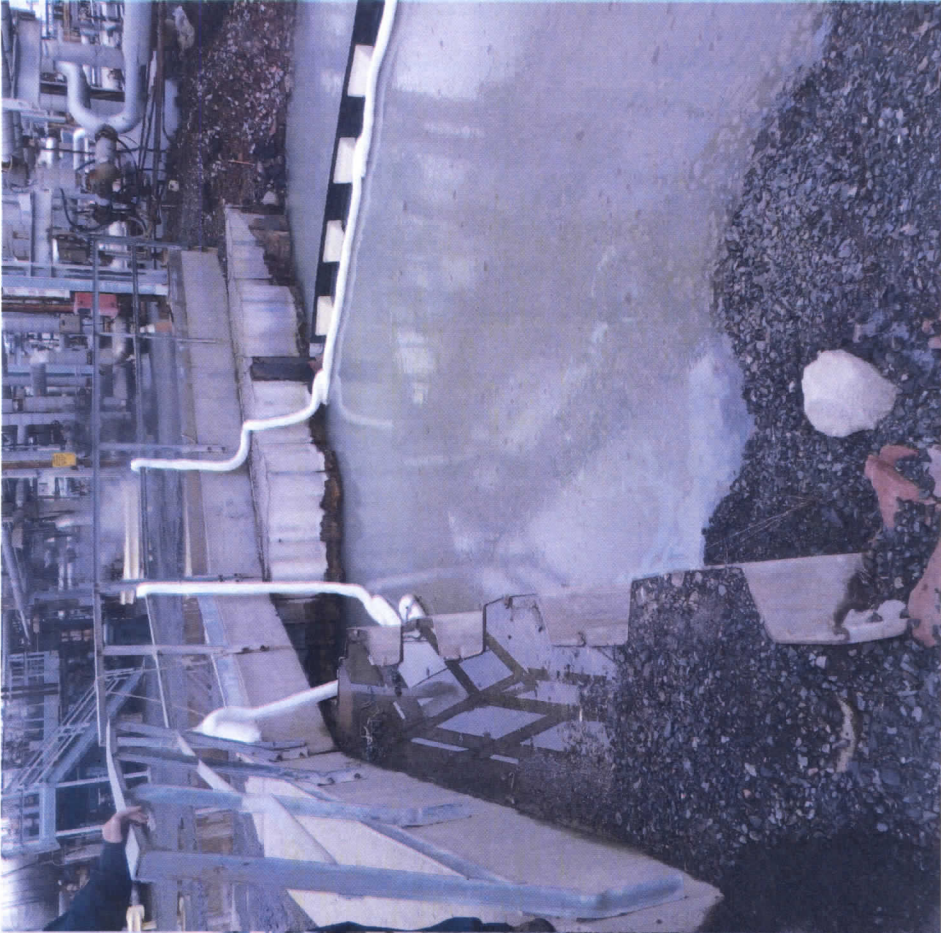
DSCN6930 - Outfall 004 – Poly Ditch – floating scum inside boom at outfall.

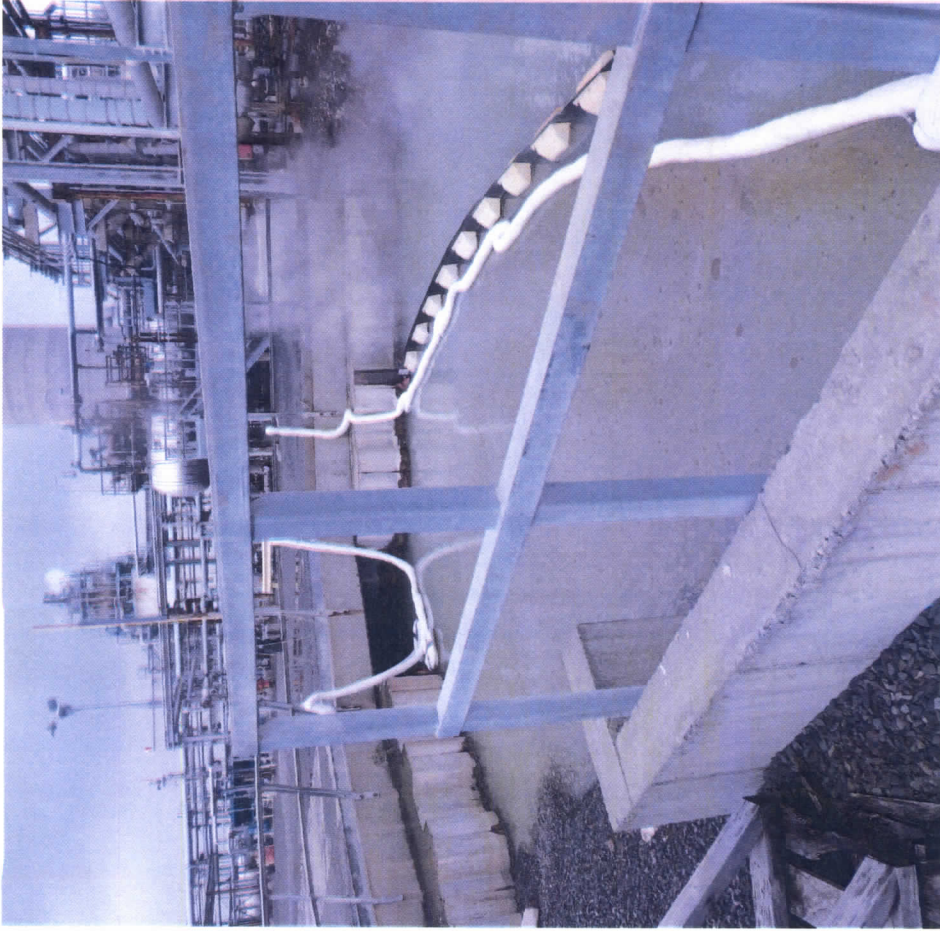
DSCN6931 - Outfall 004 – Poly Ditch – floating scum inside boom at outfall.

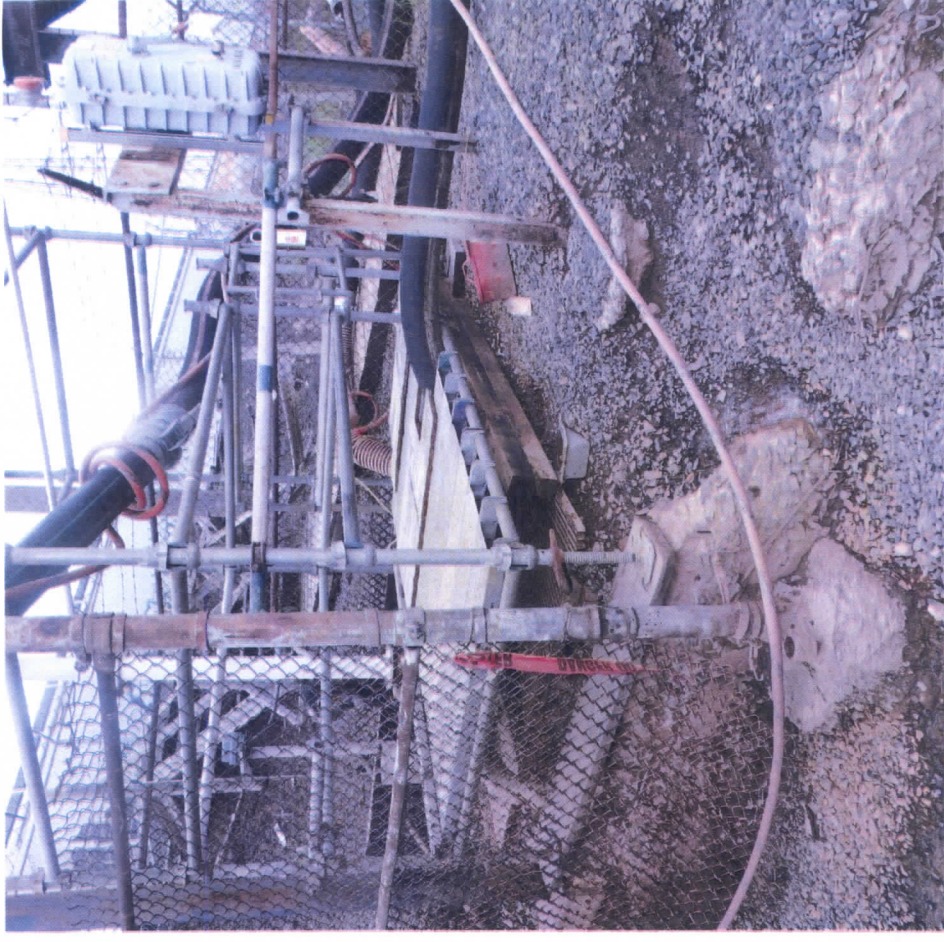
DSCN6935 - Diesel Pump hoses to control process wastewater overflows from Infineum Process sewer

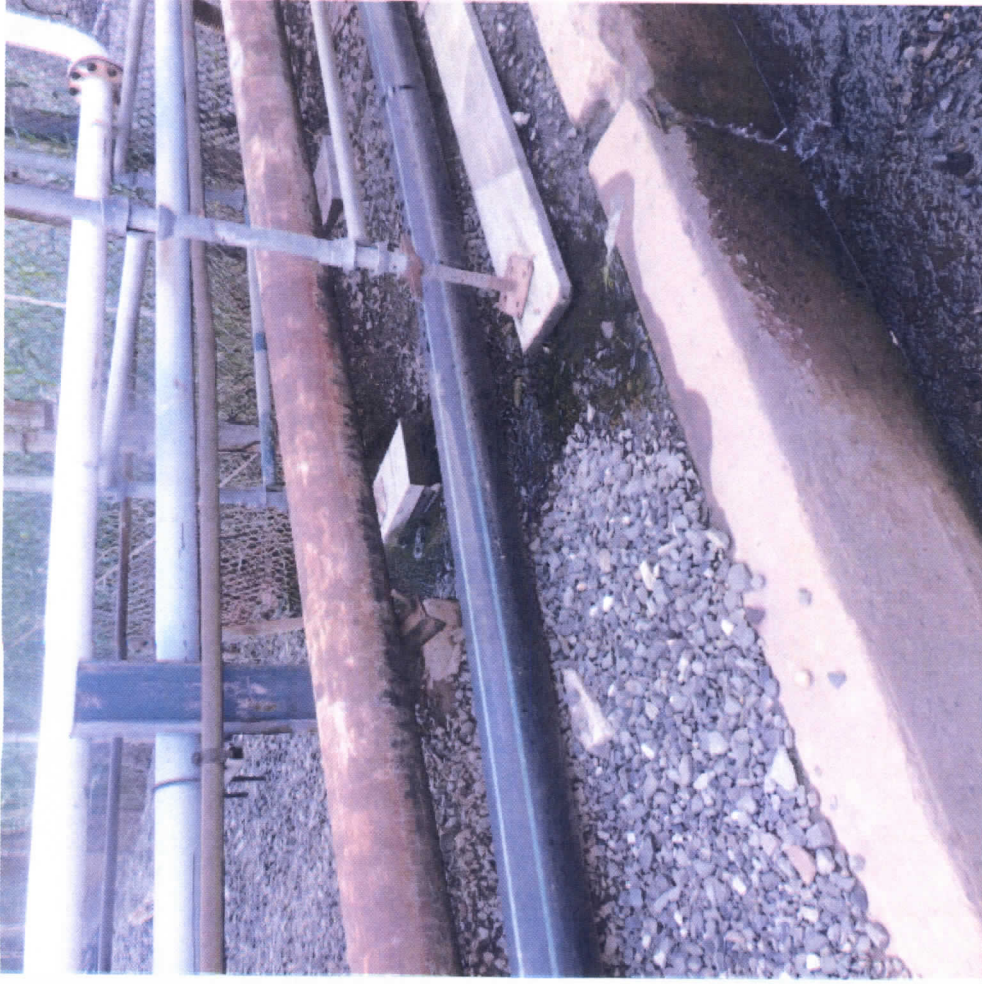
DSCN6936 – flow entering area near diesel pump for Infineum Process Sewer Overflows
